# CHAPTER 10

## Live Oak Crash Analysis

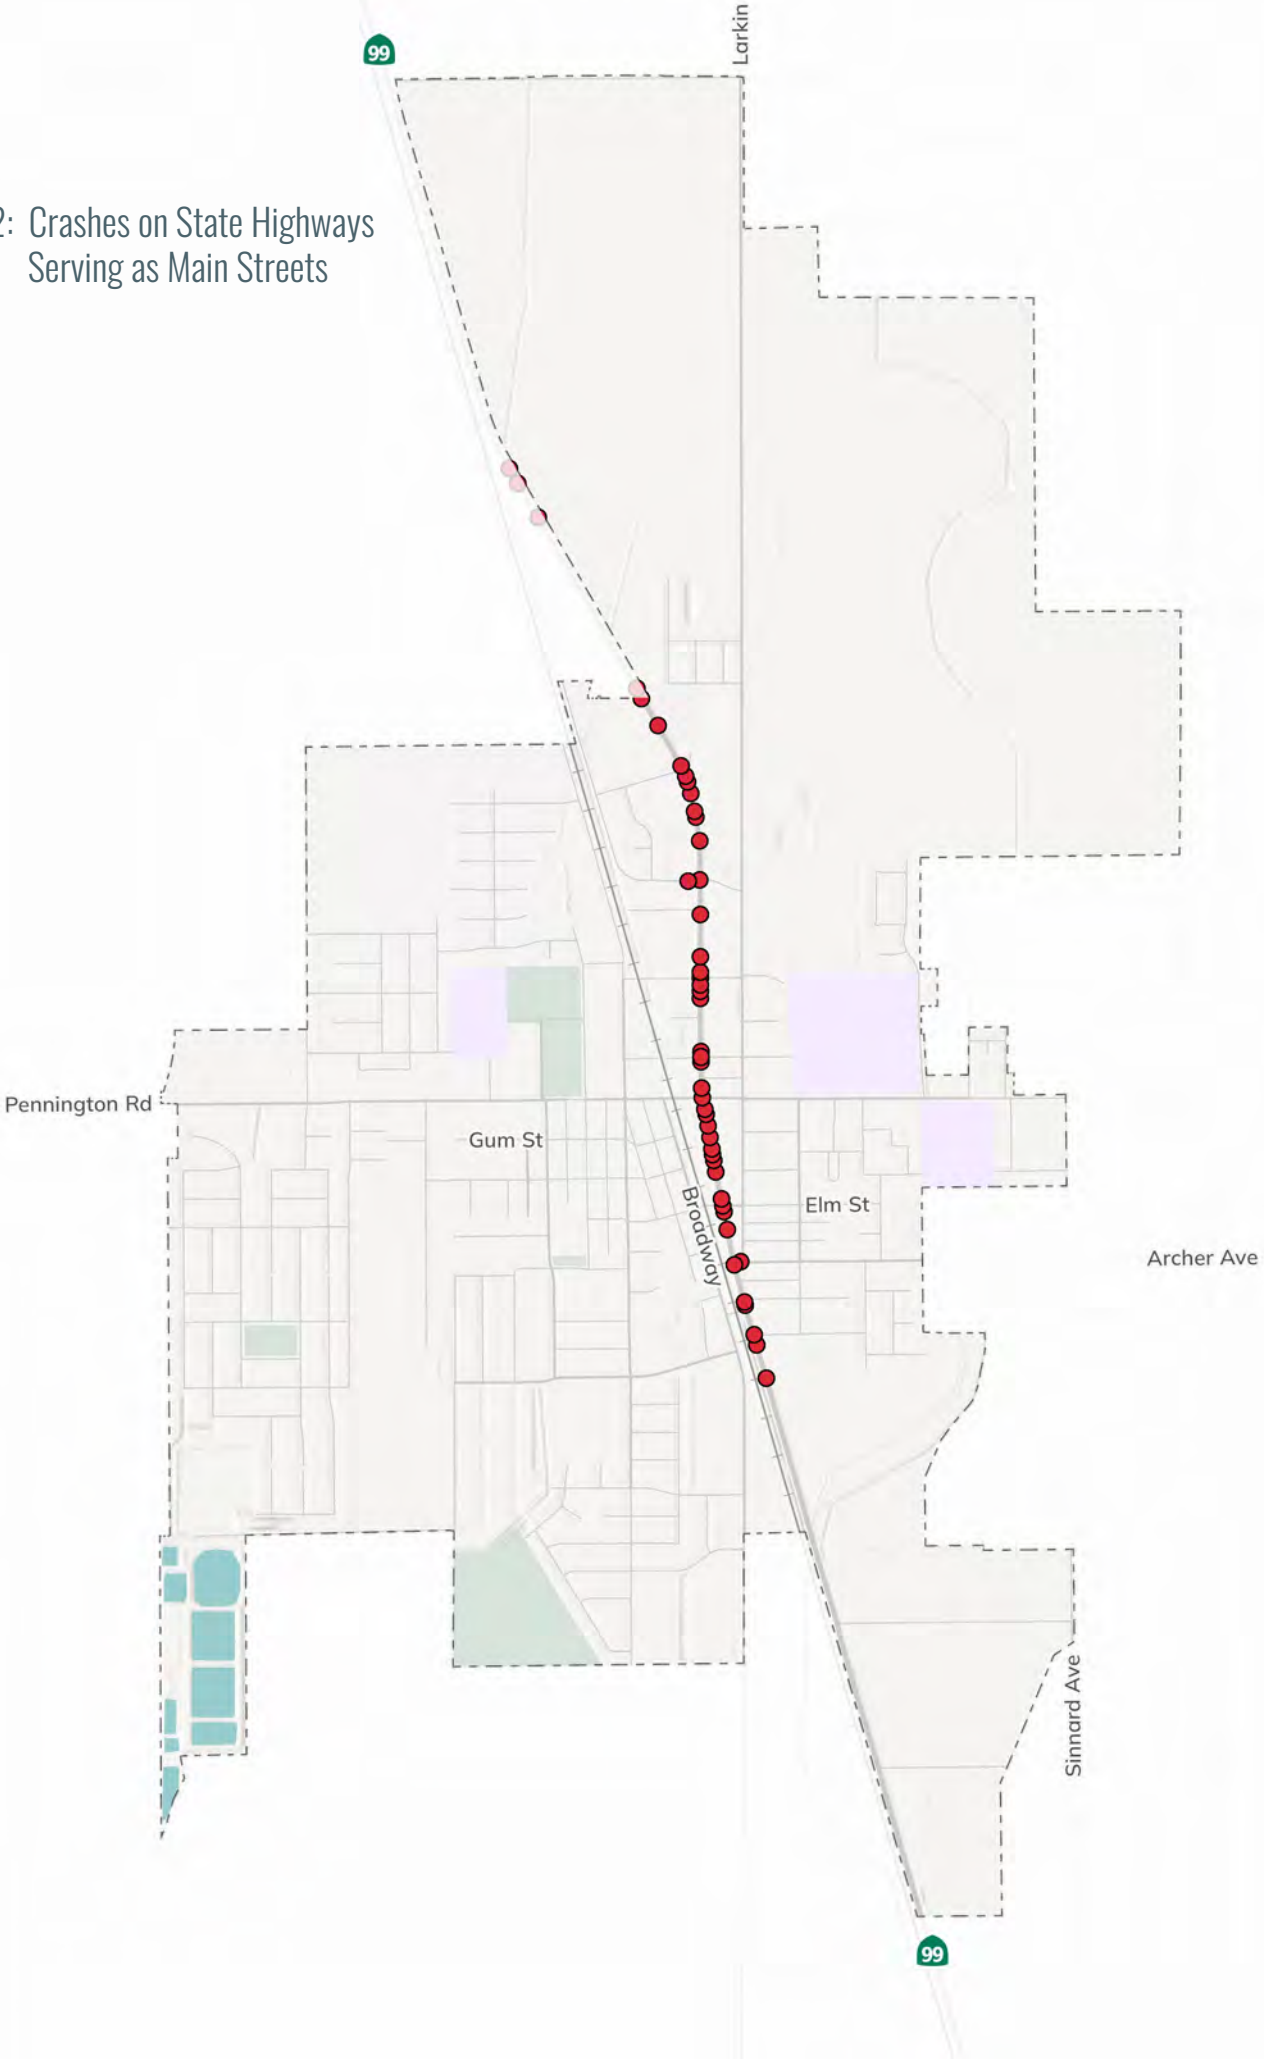
Figure 10.12: Crashes on State Highways Serving as Main Streets

55 (51%) Total Crashes

3 (60%) KSI Crashes

State Route 99/Live Oak Boulevard is a north-south highway that serves as a main street in Live Oak. Major improvements were made to this corridor within the boundaries of the city between 2020 and 2022. These upgrades led to some positive safety outcomes, including a reduction in overall crash frequency. However, they also coincided with a gradual increase in the severity of crash outcomes. A later section presents a focused case study on the crash history of and improvements made to State Route 99.

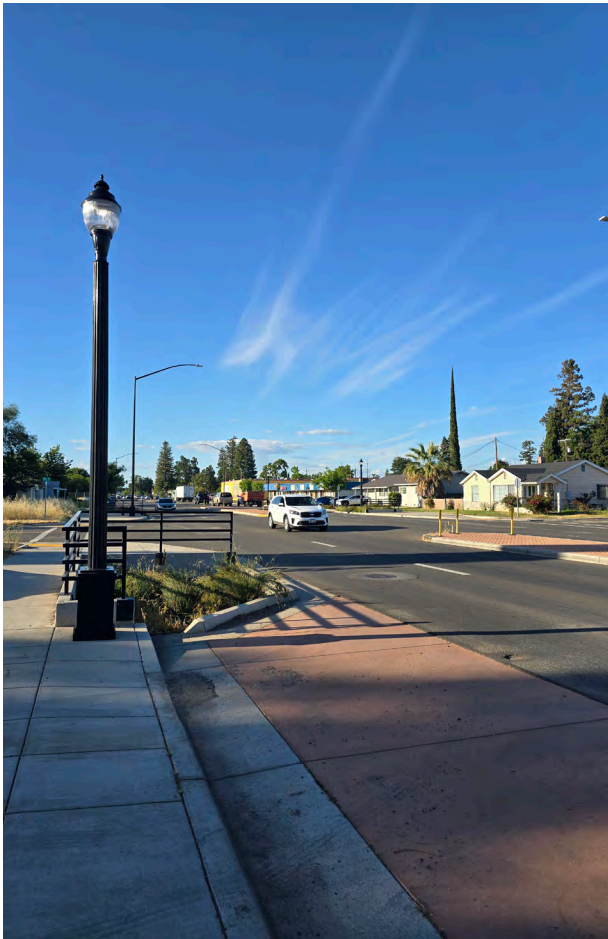
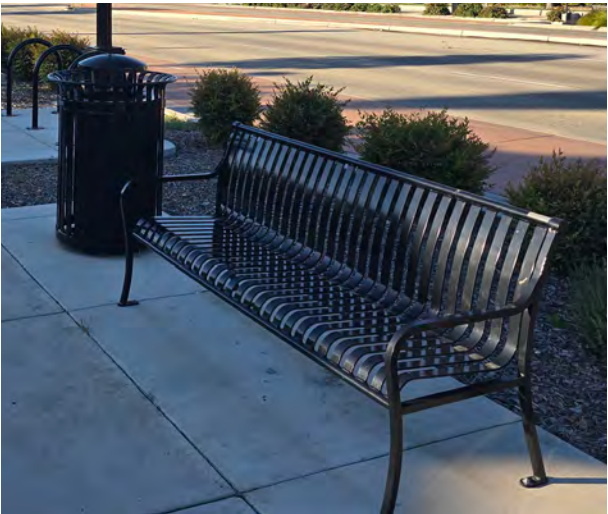
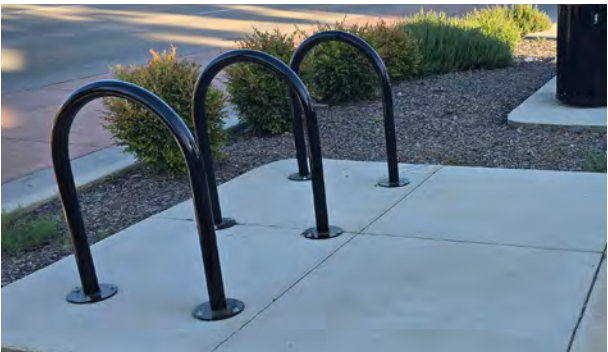
📷 Upgrades along the corridor include lighting, landscaping, median islands, benches, trash bins, and bicycle racks

at Kola Street. The corridor was widened from two lanes to four lanes with either a median, two-way left-turn lane or room for left-turn pockets at intersections. A pedestrian-focused downtown environment was achieved via enhancements in parking, wayfinding signage, landscaping, and facilities for both bicyclists and pedestrians. New sidewalks with bulbouts, curbs, and gutters were constructed, and improvements were made to existing ones. Curb ramps were upgraded to meet current Americans with Disabilities Act (ADA) standards, ensuring greater accessibility for all users. Clay-colored stamped parking bays, decorative streetlamps, trees, and benches were added.

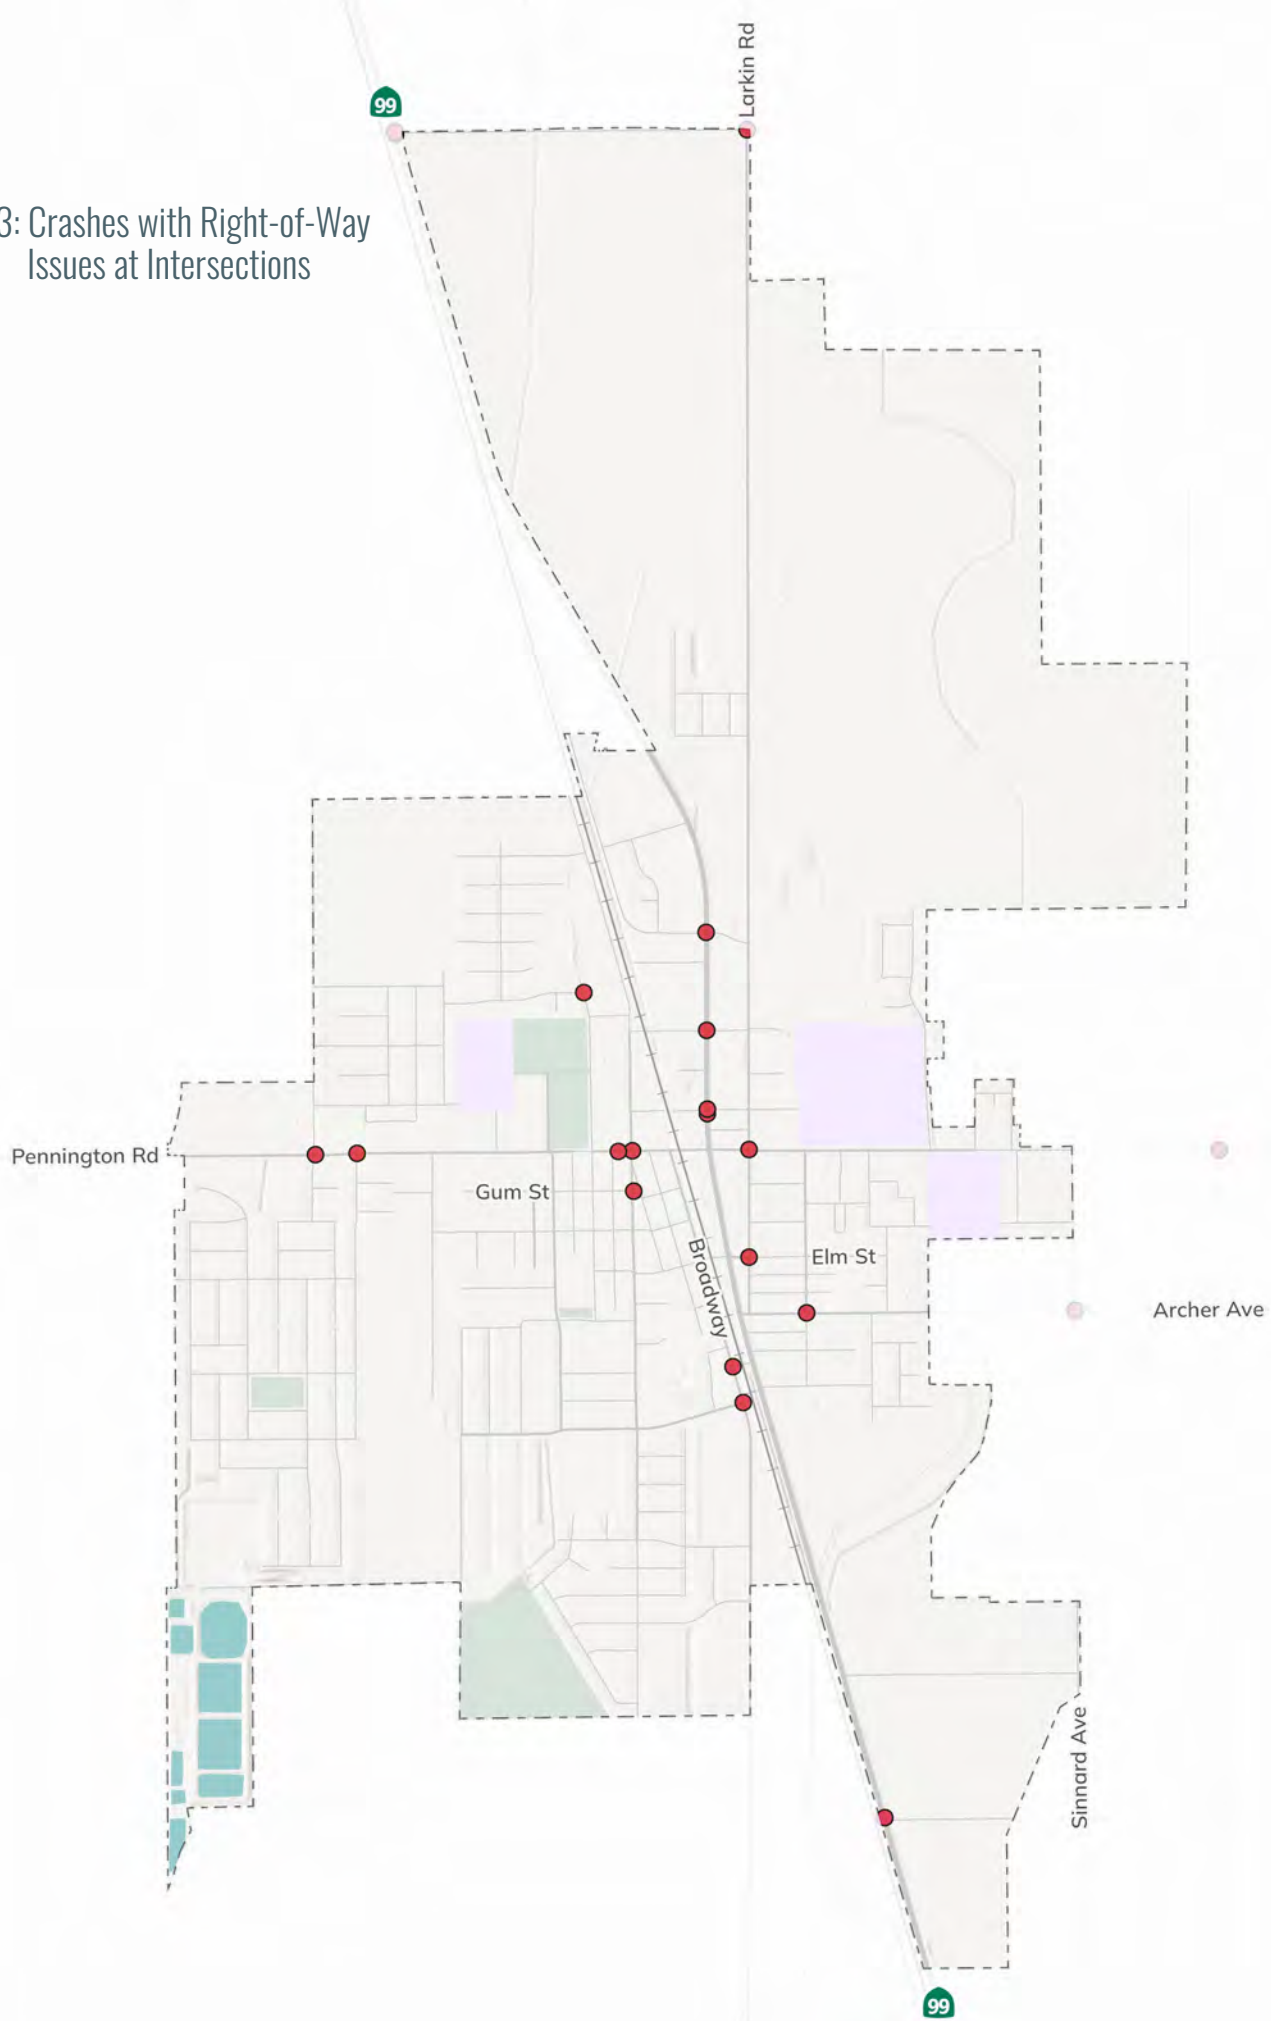
Figure 10.13: Crashes with Right-of-Way Issues at Intersections

A total of 31 crashes (29 percent) occurred at intersections where the primary cause was failure to yield the right-of-way. Of these 31 crashes, 2 resulted in a KSI crash. These incidents stemmed from drivers failing to yield to oncoming or cross traffic that legally possessed the right-of-way. In many cases, motorists either misjudged the speed and distance of approaching vehicles or did not come to a complete stop at the appropriate distance from the main thoroughfare. As a result, all but one culminated in a broadside, or T-bone, crash—an especially dangerous type of crash. These types of crashes are often severe due to the limited protection on the sides of vehicles, highlighting the critical importance of right-of-way compliance at intersections.

Crashes with these right-of-way issues tended to involve vehicles pulling out of driveways, and intersections where side streets are controlled by stop signs, while the main thoroughfare was uncontrolled. Most of these occurred along SR 99 and Pennington Road.
